Sustenance of CGC Operation through Harnessed Fouling

A case study of Ethylene plant

Mangesh Shenwai, Ingenero • Manas Karnure, Ingenero

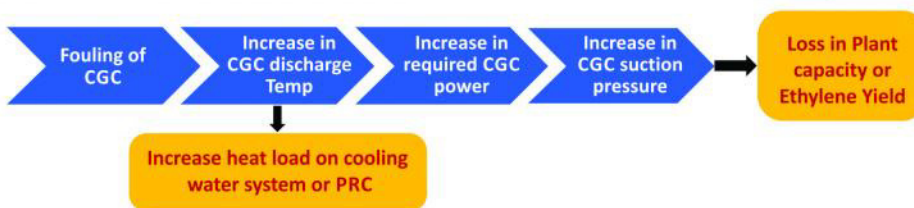
- Analysis of online operating parameters (like increased BFW injection, CGC turbine extraction & condensing stage demand valves (% Opening), CGC suction/discharge pressure) indicates loss in polytropic efficiencies of CGC.
- Simulation indicates increased power consumption, significant drop in CGC 2nd stage efficiency and slight drop in CGC turbine extraction stage efficiency.
- Increased CGC suction pressure reduces overall ethylene yield.
- Further loss in efficiency of CGC train will require reduction in plant throughput.
- Alternatively if throughput is maintained at current level (106% of design), increase in suction pressure will be required.
- Both the cases will result in loss of ethylene production.

Effect of decrease in CGC polytropic efficiency represented as follows:

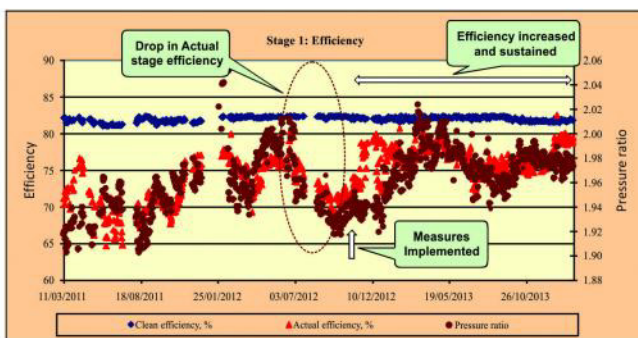
Improvement in CGC 1st stage efficiency after implementing recommendations are illustrated in the following graph

- Controlled test with modified wash oil dozing rate and frequency was carried out for CGC 1st stage
 - Significant improvement was observed in 1st stage efficiency after modified wash oil injection rates and arrested further drop in CGC 2nd stage efficiency.
- Suggested modified wash oil dozing plan for LP as well as MP casing based on the results of trial
- Max possible water injection without affecting integrity of casings determined and suggested to maintain possible water injection rate in each stage.
- Suggested to analyze polymeric material from CGC 1st stage inter-cooler and CGC casing low point drains to identify the fouling mechanism and precursors.
- Suggested to install flow meters for measuring BFW injection flow rate to each stage during next available opportunity. This will help in accurate tracking of CGC efficiencies.

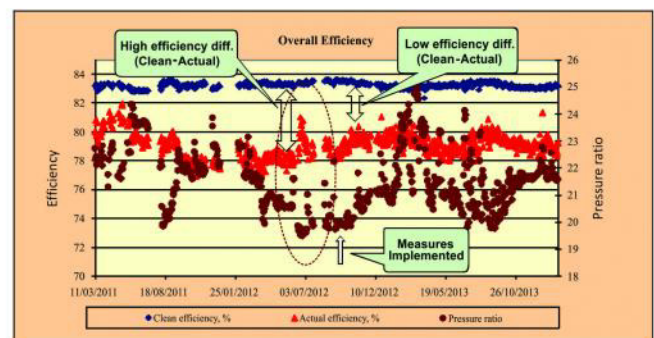
Improvement in CGC efficiency difference (Clean-Actual) after implementing recommendations are illustrated in the following graph
